Manhole Inspection Summary

Manhole # S37AA_010MH

Insp Date: **1/9/08 12:24 PM**

Location Address: **e.madison**

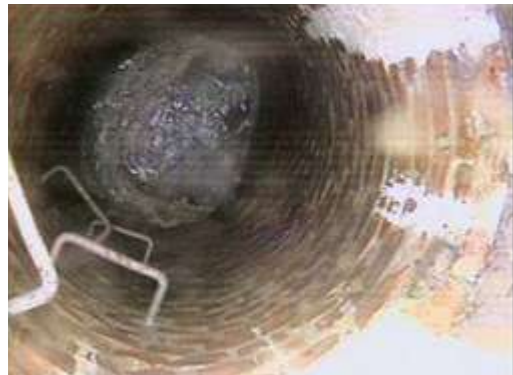
Defect 1

Condition: ☐ Sound ☐ Cracked ☐ Root Intrusion ☐ Deteriorated ☐ Leaks ☒ **Debris**

channel debris

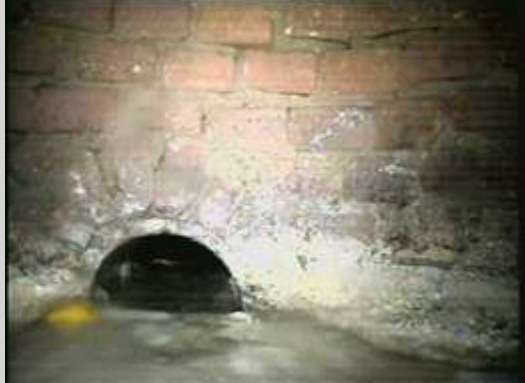
12 O'Clock Outflow

8 in. Circular Gravity Sewer
Pipe Out @ 12 O'Clock
